Dalvui Battery Energy Storage System (BESS), Terang

Complex Cultural Heritage Management Plan

Tilt Renewables Australia Pty Ltd

Reference: 510575 Revision number: V05

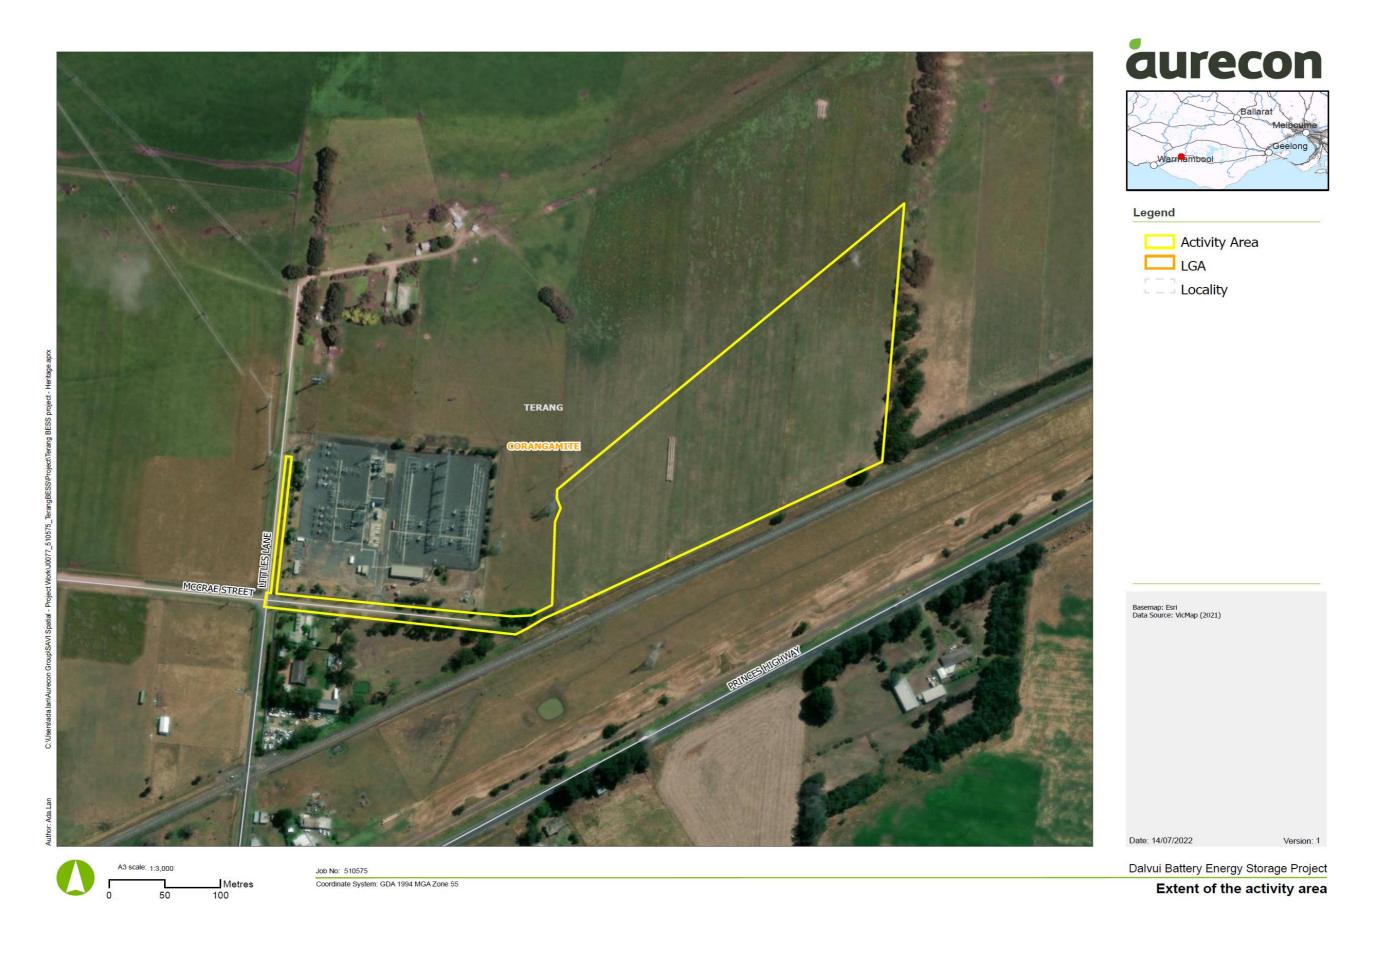
Figure 4.1: Extent of the activity area

The extent of the activity area is shown in Figure 4.1. It covers a total surface area of 57,519 m². The activity area is located immediately east to the existing Terang terminal station and is accessed from McCrae Road, Terang. It includes a small portion of road reserve on McCrae Road and Littles Lane as shown in Figure 4.1.

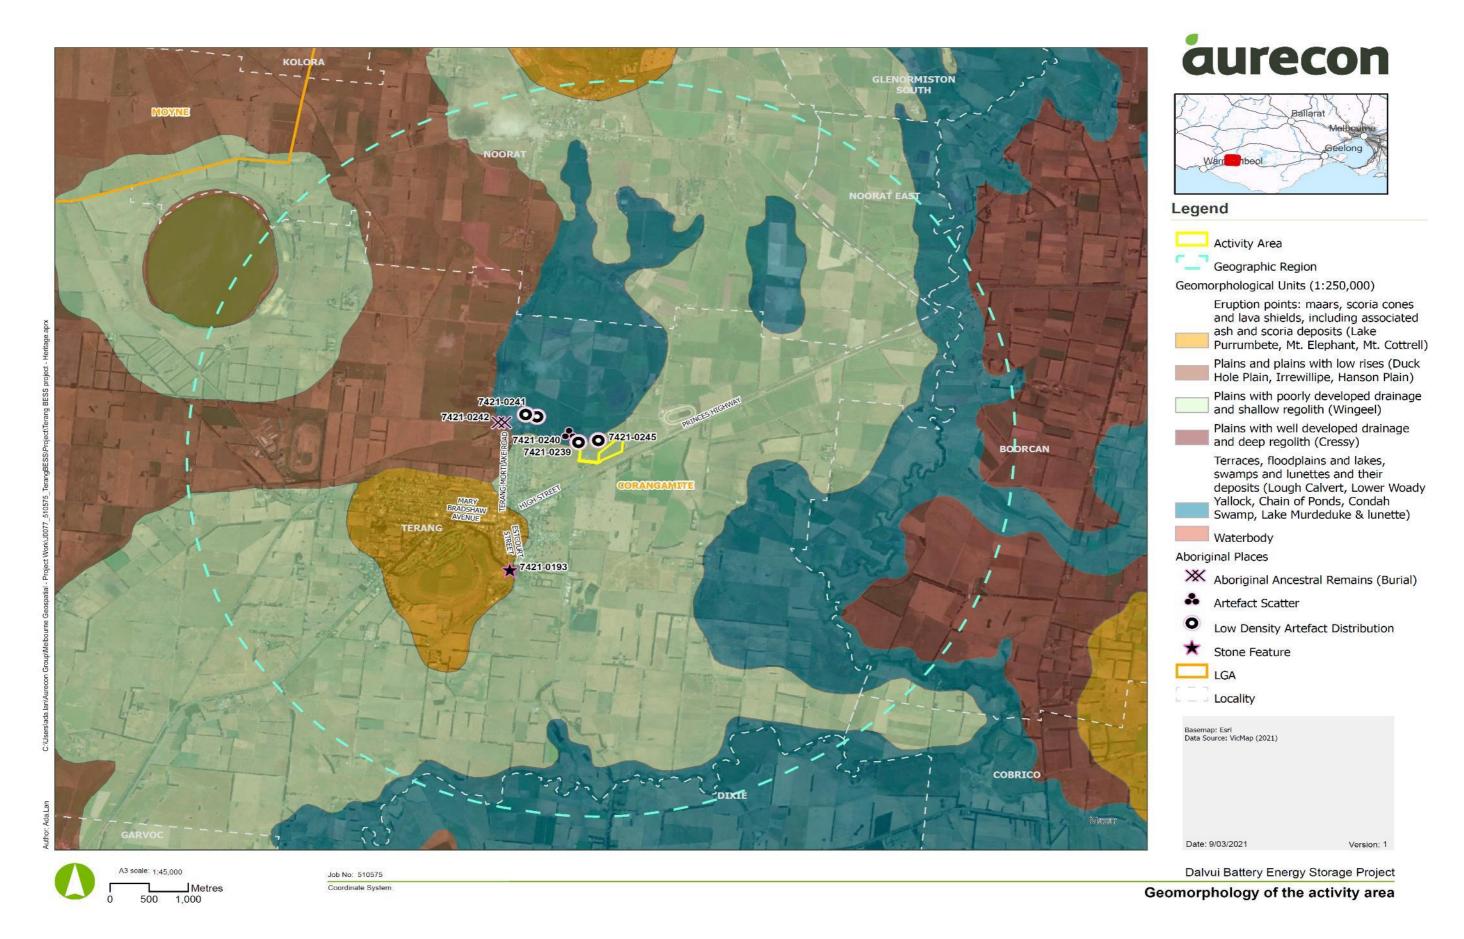
Figure 6.3: Geomorphology of the activity area

The most prominent natural feature located within close proximity to the activity area is Lake Ondit, located approximately 1.5 km west of the activity area. The activity area is located on a geomorphic land system known as 'plains with poorly developed drainage and regolith'.

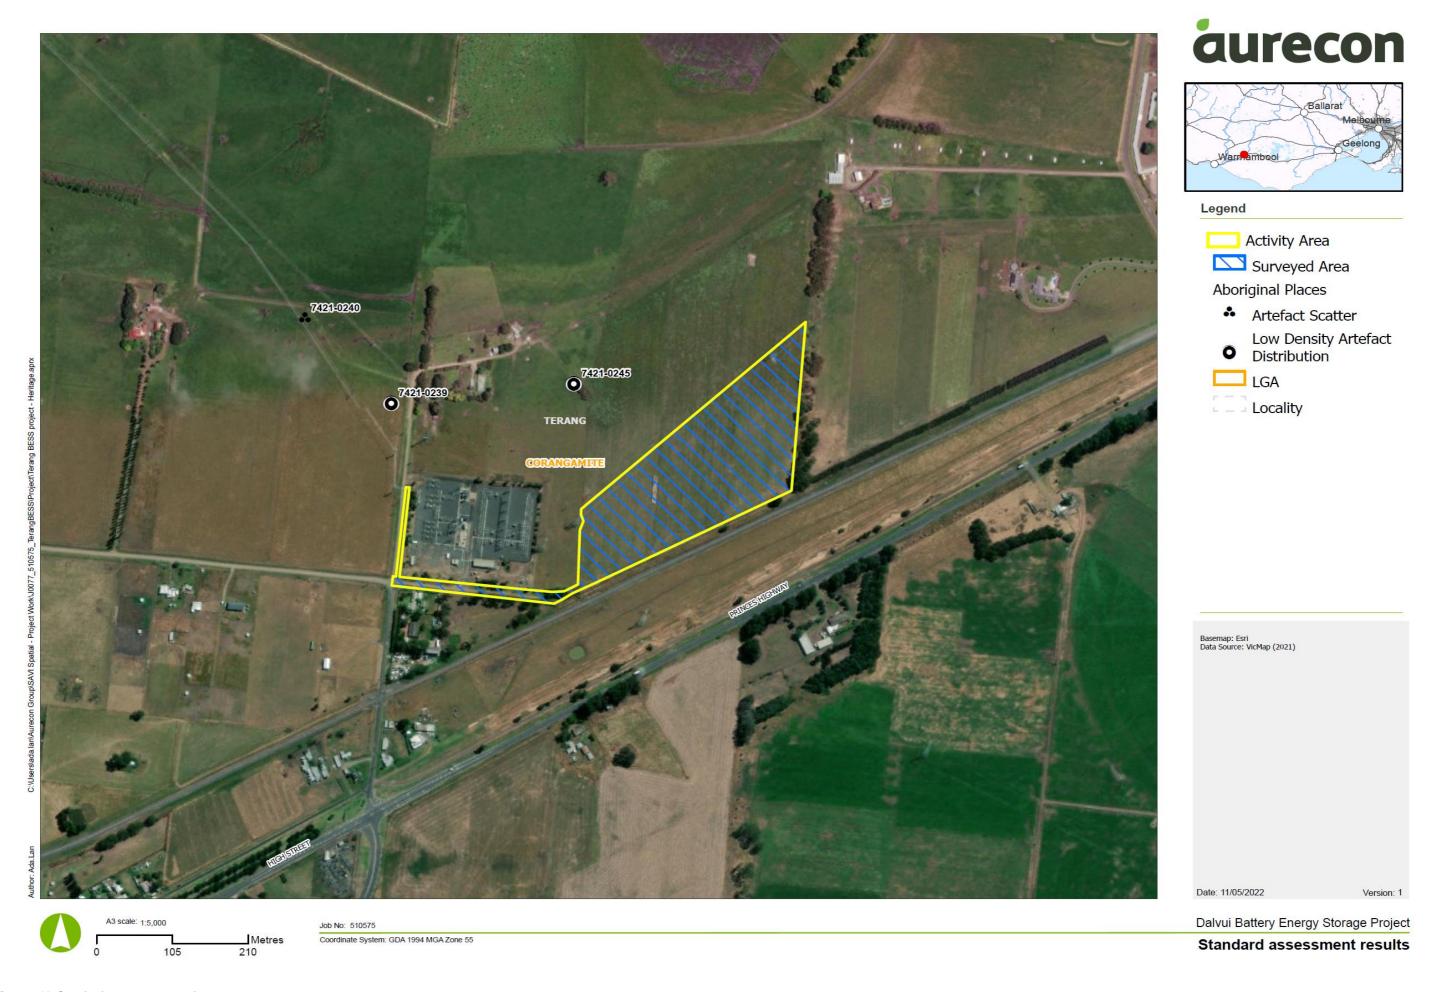
Figure 7.11: Standard assessment results

The standard assessment survey results reinforced the desktop assessment predictive model finding that suggested the volcanic plain landform will have low archaeological sensitivity. During consultation with the RAP, concerns were raised around the proximity of known Aboriginal places to the existing activity area which may suggest there is some potential for further Aboriginal cultural material to be present. Concerns were also raised around the intensity of ongoing development at the location, particularly in relation to recent CHMPs that have been approved and surround the Terang terminal station (CHMP 17073, 16306 and 14295). These proposed developments were viewed by the RAP as increasing the cumulative impact to an area (Pejark Marsh) known to have archaeological significance. The intensity of development also reduces future opportunities to conduct archaeological investigation at the location. Visibility was also typically poor throughout the activity area providing further challenges for understanding the archaeological significance of the activity area. For these reasons, complex assessment was agreed upon in accordance with r 64 of the

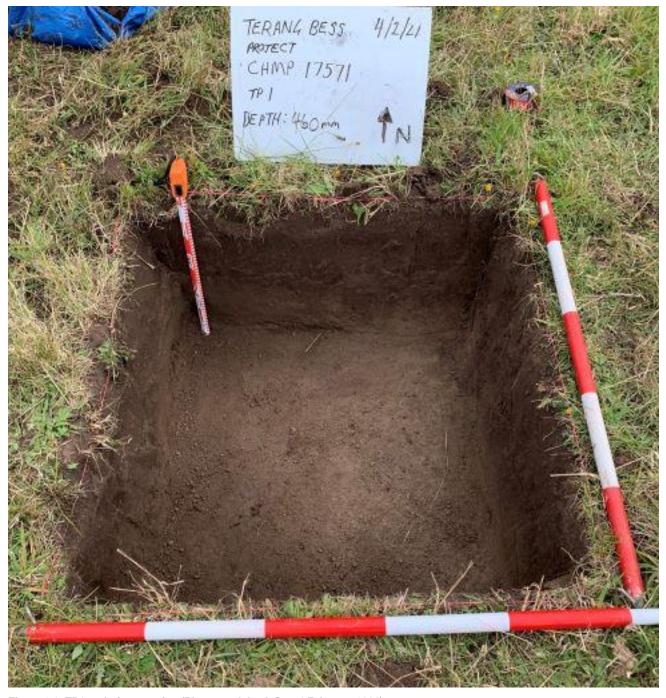
Figure 8.1: TP1 end of excavation (Photograph by A Carr 4 February 2021)

SU	Depth (mm)	Description	Munsell	рН
1	250	Very dark brown silty loam which has been ploughed. Small rootlets present.	7.5 YR 2/2.5	5.5
2	450	Dark brown silty clay with ironstone gravel inclusions increasing with depth.	7.5 YR 3/3	6
3	460	Strong brown clay base.	7.5YR 5/3	6

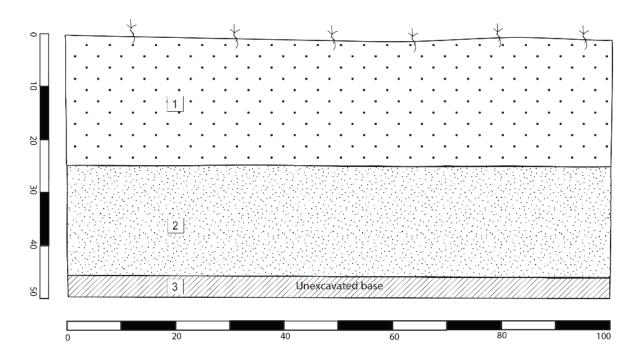
MGA Zone: 54 144122E/ 5760506N Excavation date: 2 February 2021

Drawn by: Laura Cross Scale: 1 : 1000 mm

1	7.5 YR 2/2.5 (very dark brown), pH 5 1/2. Very dark brown silty loam (0-250 mm).
2	7.5 YR 3/3 (dark brown), pH 6. Dark brown silty clay (250-450 mm) Infrequent ironstone gravel inclusions increasing with depth.
3	7.5 YR 5/3 (strong brown), pH 6. Strong brown firm clay base (450-460 mm).

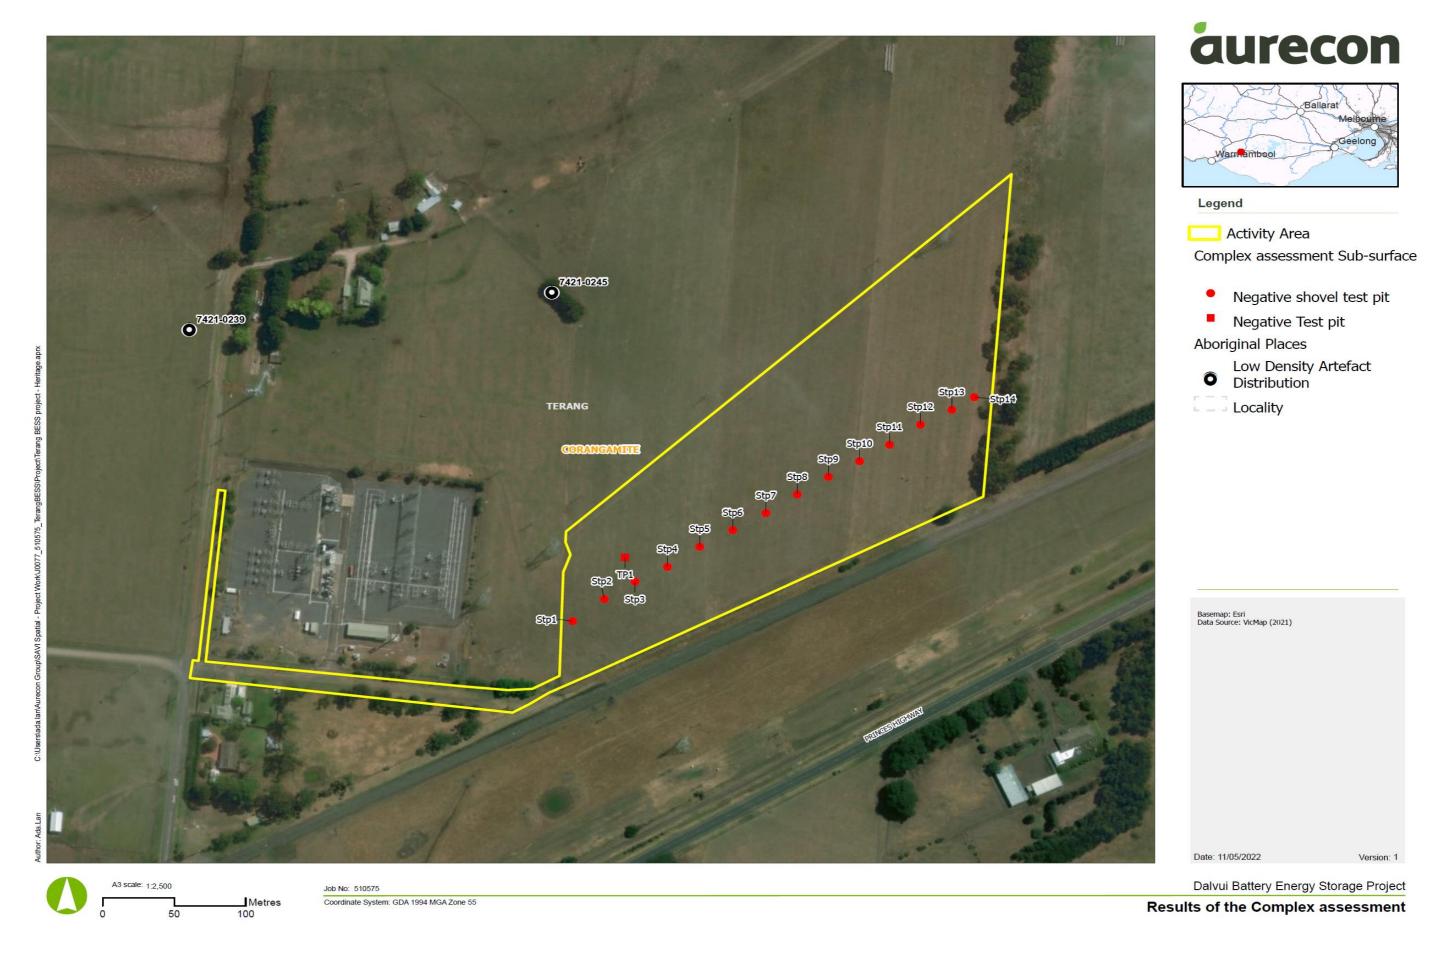
Figure 8.4: Complex assessment results

Over two days, the main aims of the complex assessment were met. The testing achieved representative coverage across parts of the activity area that will be impacted by the activity; subsurface conditions and stratigraphy were investigated across the volcanic plain landform and areas of archaeological potential identified during the standard assessment were investigated. In total one 1 x 1 m TP and 14 0.5 x 0.5 m STP were excavated (a total surface area of 4.5 m²). No Aboriginal cultural material was recovered.

A number of predictions made during the desktop assessment were confirmed as a result of the testing, including that prior disturbance to the activity area such as ploughing will have adversely impacted subsurface conditions. The complex assessment also confirmed the prediction that the volcanic plain landform present in the activity area will have low archaeological significance. Overall, the complex assessment has shown that the activity area has been determined to have low archaeological sensitivity, with low potential for subsurface cultural deposits to be present.
