# Dundonnell Wind Farm Brolga Compensation Plan

Year 5 wetland performance report  
December 2025

Document Title: Dundonnell Wind Farm Brolga Compensation Plan Year 5 Wetland Performance Report

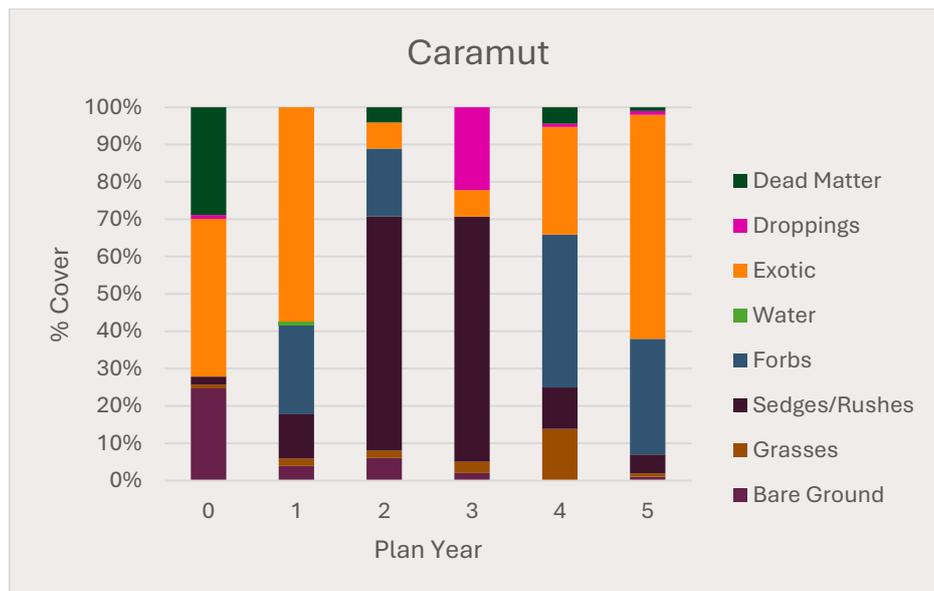
Figure 1 Caramut coverage % by type.

Plan Year	Date	Coverage Type (%)							
		Bare Ground	Grasses	Sedges/Rushes	Forbs	Water	Exotic	Droppings	Dead Matter
0	10/12/2020	24	1	2	0	0	41	1	28
1	7/12/2021	4	2	12	24	1	58	0	0
2	28/02/2023	6	2	62	18	0	7	0	4
3	7/12/2024	2	3	65	0	0	7	22	0
4	27/11/2024	0	16	13	47	0	33	1	5
5	11/11/2025	1	1	5	31	0	60	1	1

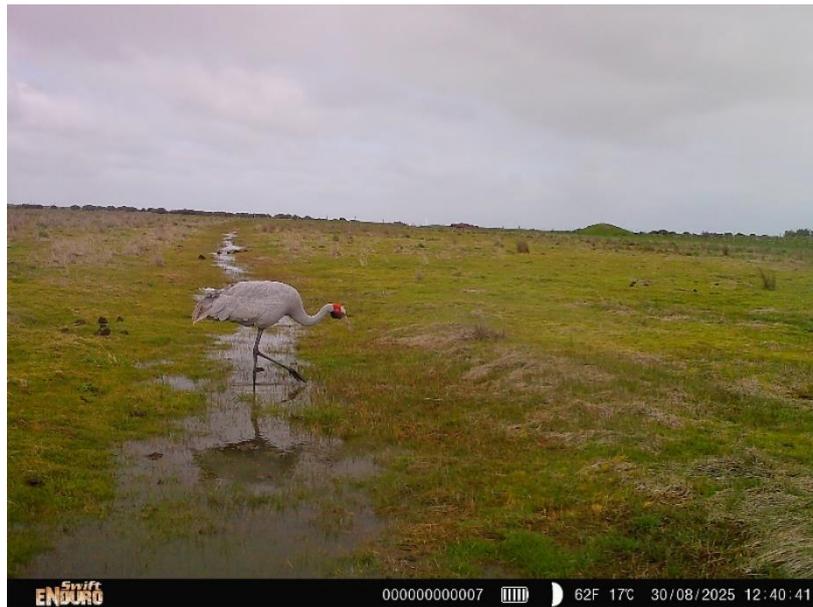
Figure 4 Caramut at maximum inundation.

Table 4 summarises inundation conditions for the wetland since the BCP started. Average annual rainfall is 662mm at BoM station 090062 Penhurst(The Gums) 15km distant<sup>2</sup>. Figure 4 and Figure 5 show inundation extent conditions for 2025. The wetland was not inundated in 2025.

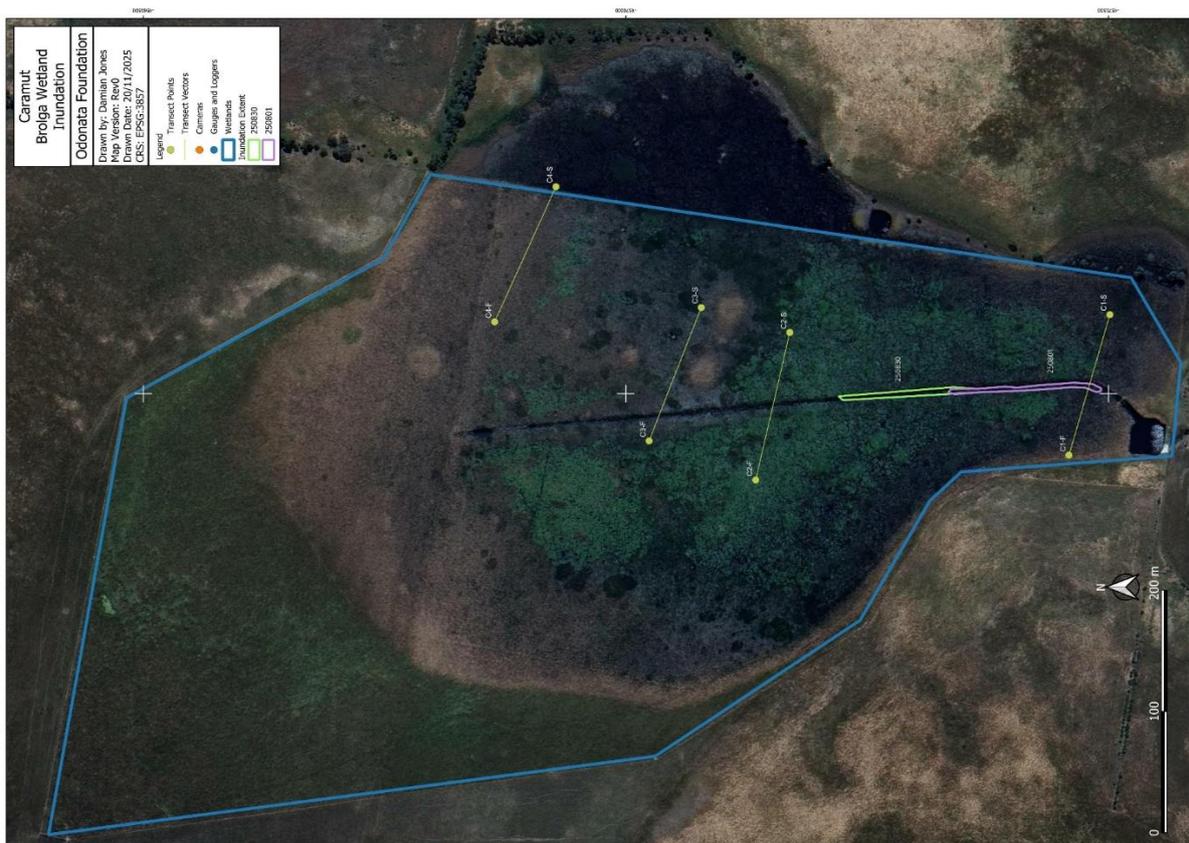
Figure 5 Caramut inundation extent

Lower than average rainfall made 2025 the third consecutive year where the wetland did not meet the wetland performance target of 30cm inundation over 75% of the wetland basin. This has had a significant impact on the composition of vegetation observed at the site, the DST outcome, and likelihood of Broilgas visiting the site. See the sections below.

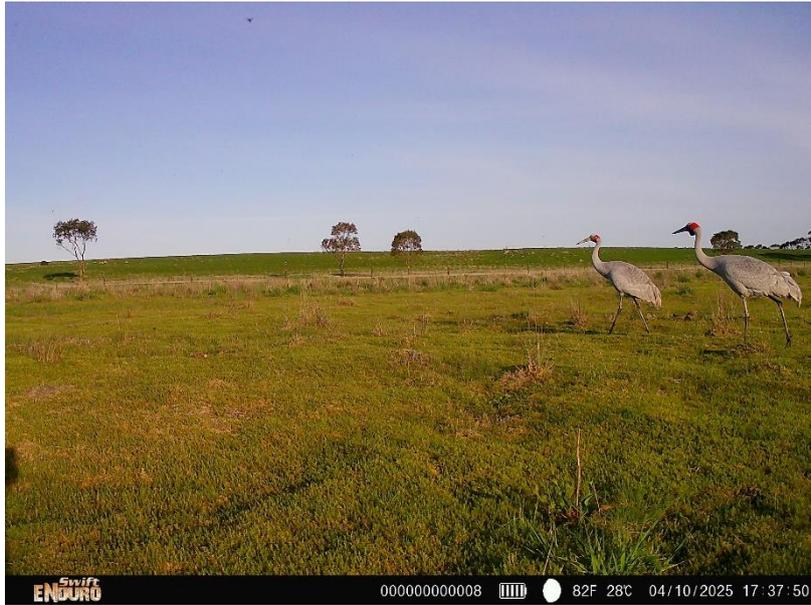
*Figure 6 Caramut Brolga sighting 4/10/25.*

Table 7 shows all brolgas sightings from the reporting period. See Figure 4 and Figure 6.

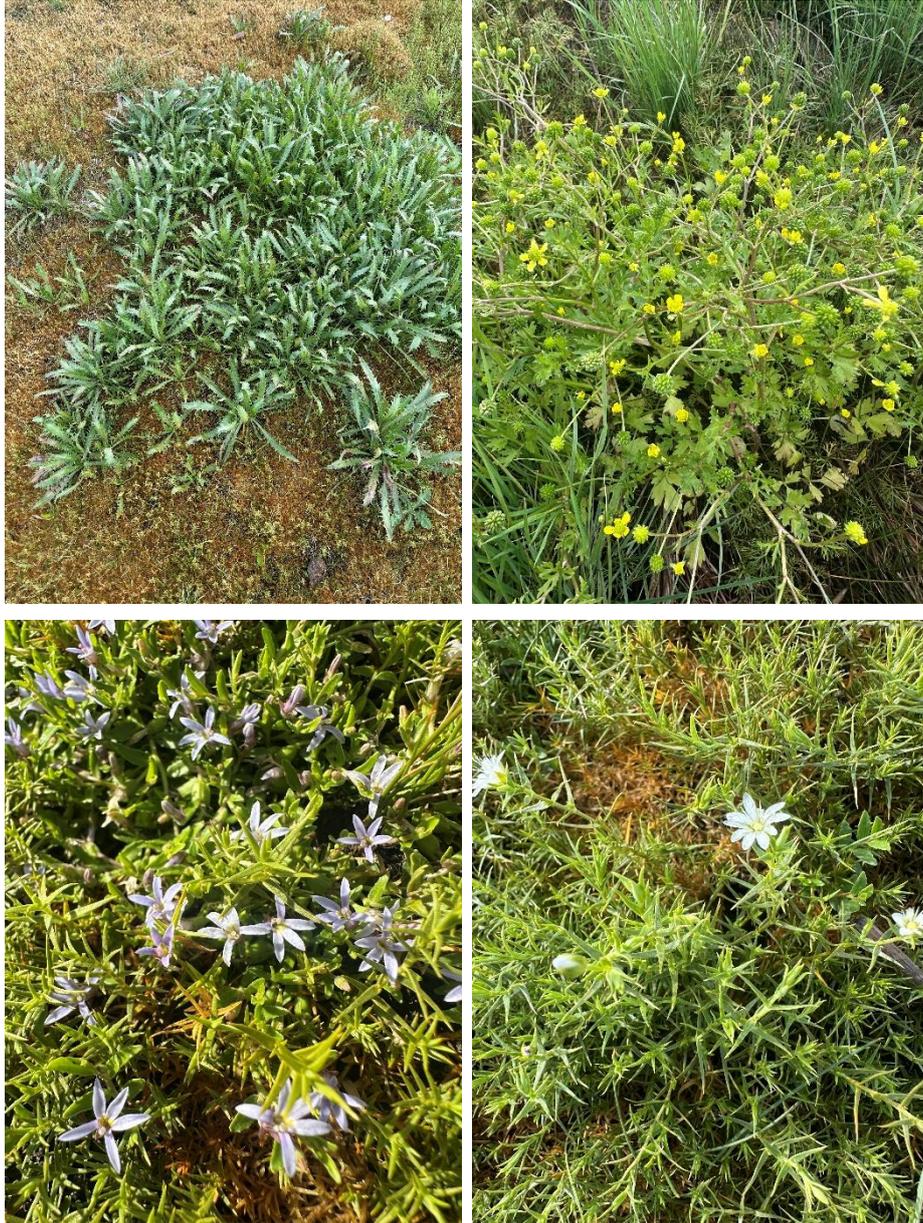
Figure 7 Caramut native herbs (L-R T-B) Blue Devils, Australian Buttercup, Poison Lobelia, Prickly Starwort.

However, it was encouraging to see significant growth of native herb species in typically inundated areas and often NOT on the survey transects. In particular (also see Figure 7):

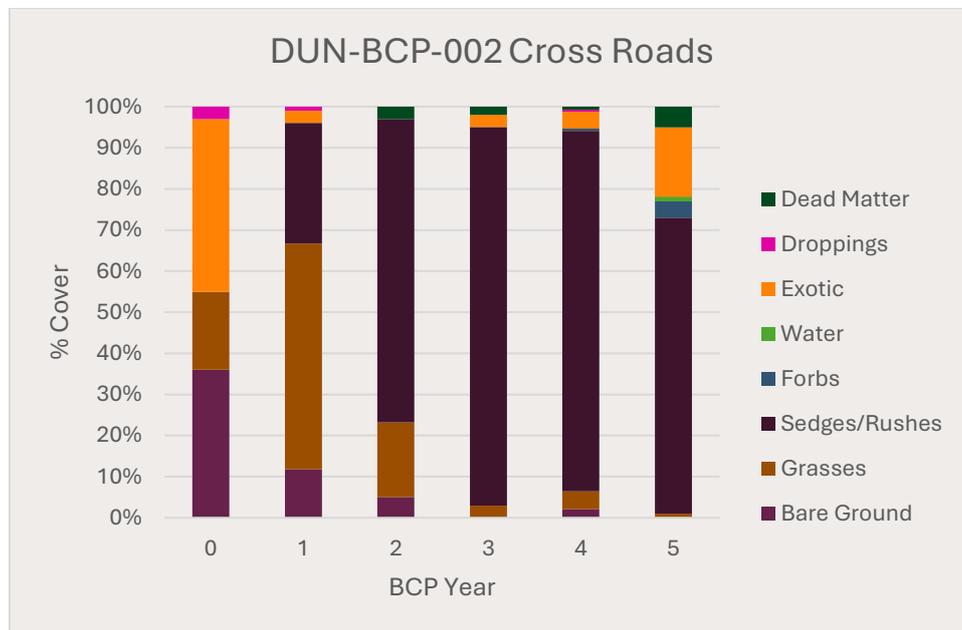
Figure 8 Cross Roads coverage % by type.

Plan Year	Date	Coverage Type (%)							
		Bare Ground	Grasses	Sedges/Rushes	Forbs	Water	Exotic	Droppings	Dead Matter
0	30/11/2020	36	19	0	0	0	42	3	0
1	15/02/2021	12	56	30	0	0	3	1	0
2	20/03/2023	5	18	73	0	0	0	0	3
3	6/12/2024	0	3	93	0	0	3	0	2
4	28/11/2024	2	4	88	1	0	4	0	1
5	10/11/2025	0	1	72	4	1	17	0	5

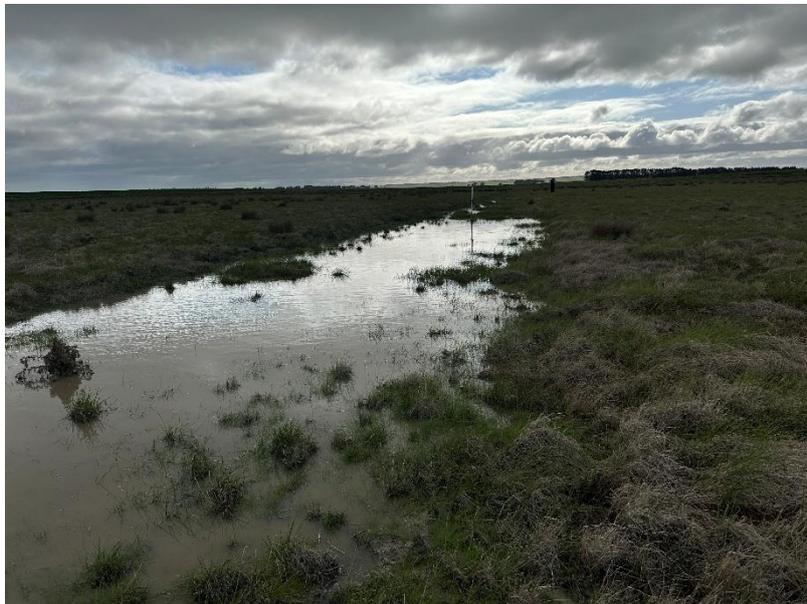
Figure 10 Cross Roads at maximum inundation.

Table 8 summarises inundation conditions for the wetland since the BCP started. Average annual rainfall is 594mm at BoM station 089082 Beaufort (Sheepwash) 7km distant<sup>4</sup>. Figure 10 and Figure 11 show inundation extent conditions for 2025. The wetland only filled within the drainage channel covering an area of about 0.2ha or 3% of the wetland to a maximum depth of <20cm. Despite this low area of inundation, the water remained in place for several months appearing to attract Brolgas and allowing frogs to breed, see Figure 12 and Figure 13.

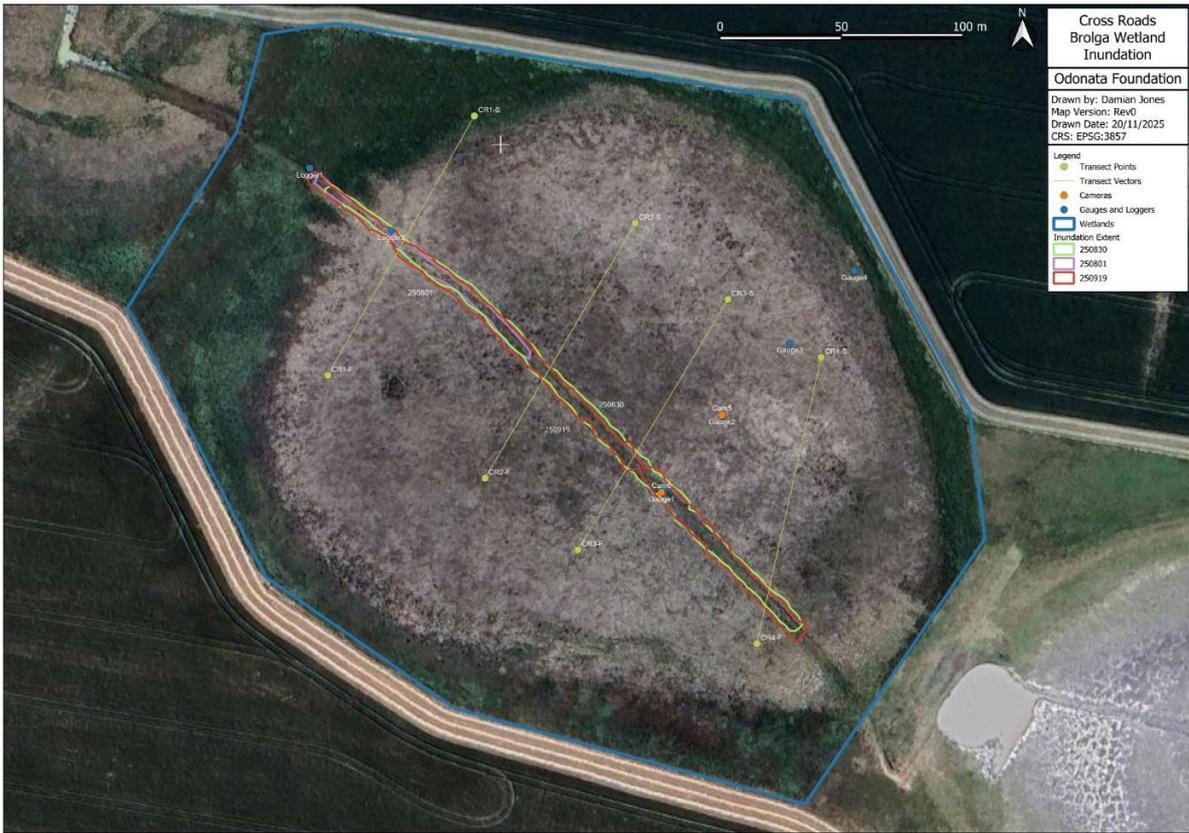
Figure 11 Cross Roads inundation extent

Lower than average rainfall made 2025 the second consecutive year where the wetland did not meet the wetland performance target of 30cm inundation over 75% of the wetland basin. This has begun to impact on the composition of vegetation observed at the site, the DST outcome, and likelihood of Brolgas visiting and nesting at the site. See the sections below.

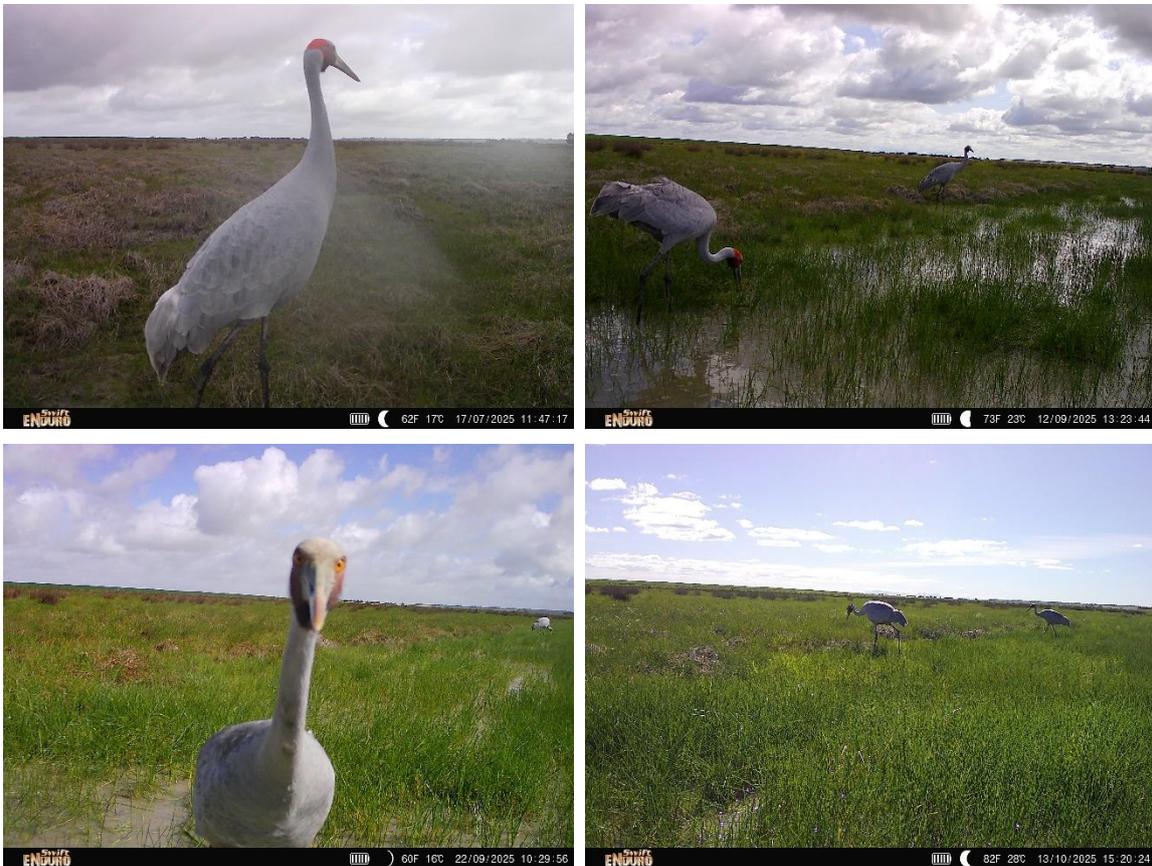
Figure 12 Cross Roads Broлга sightings (L-R T-B) 17/7/25, 12/9/25, 22/9/25, 13/10/25.

Table 11 shows all brolgas sightings from the reporting period. See Figure 12 for examples of Brolga images from wildlife cameras.

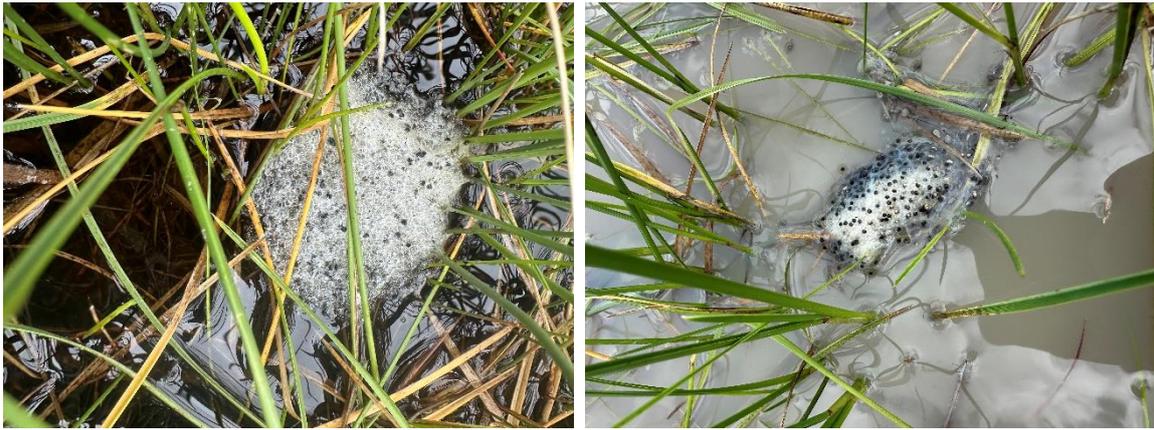
*Figure 13 Cross Roads frog eggs.*

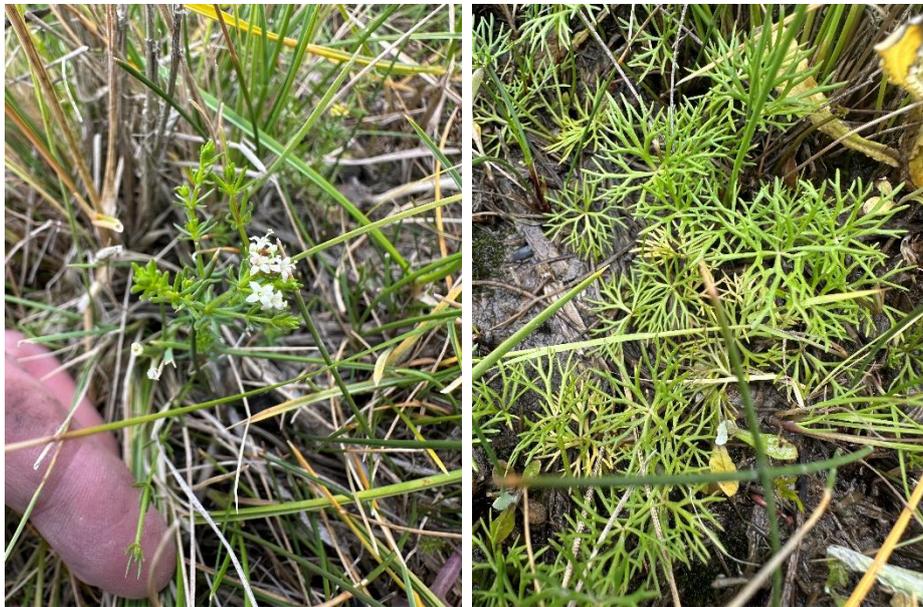
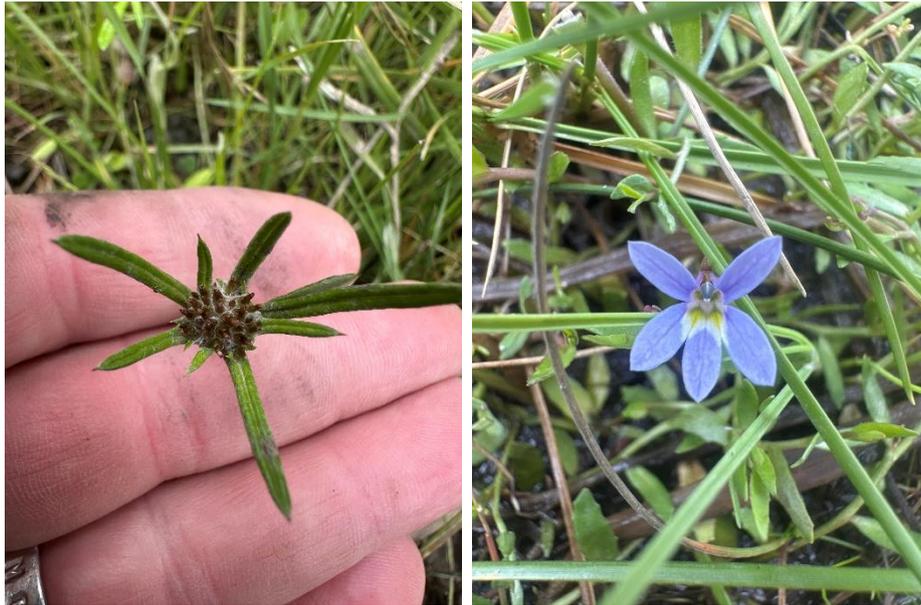
Figure 14 Cross Roads native herbs (L-R T-B) Common Woodruff, River Buttercup, Common Cudweed, Poison Lobelia.

However, it was still encouraging to see good quantities of native herb species, typically in previously inundated areas and often NOT on the survey transects. In particular (also see Figure 14):

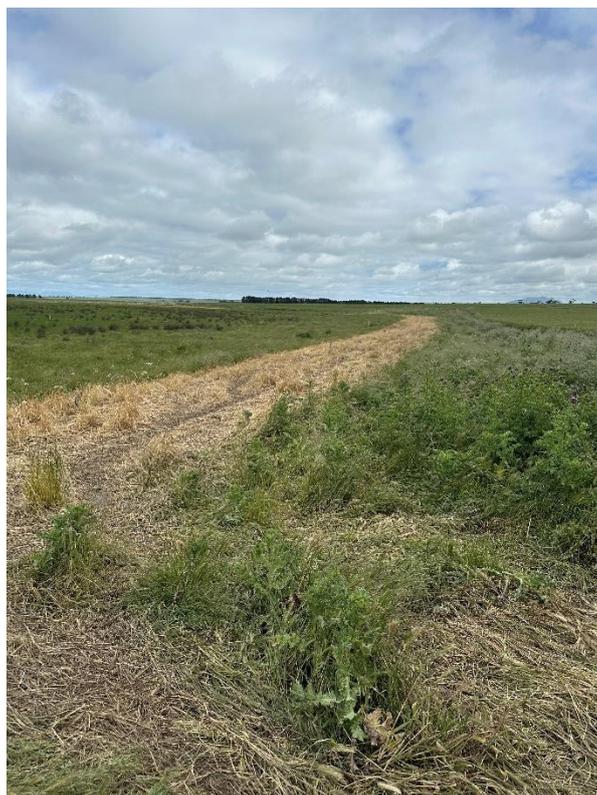
Figure 15 Cross Roads impact of boom spraying of wild oats on the wetland boundary.

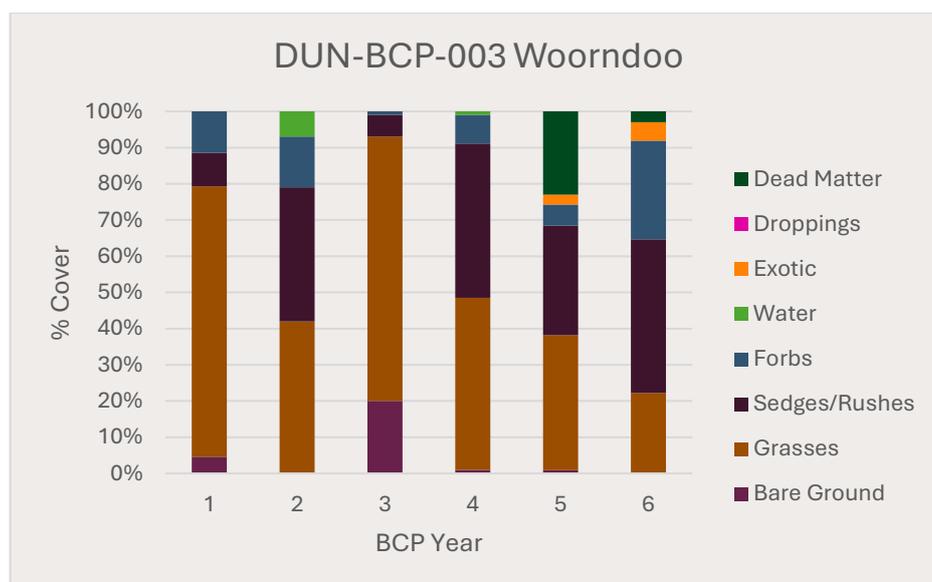
Figure 16 Woorndoo coverage % by type.

Plan Year	Date	Coverage Type (%)							
		Bare Ground	Grasses	Sedges/Rushes	Forbs	Water	Exotic	Droppings	Dead Matter
0	18/11/2020	4	65	8	10	0	0	0	0
1	22/12/2021	0	42	37	14	7	0	0	0
2	7/03/2023	20	73	6	1	0	0	0	0
3	7/12/2024	1	48	43	8	1	0	0	0
4	5/12/2024	1	37	30	6	0	3	0	23
5	11/11/2025	0	22	42	27	0	5	0	3

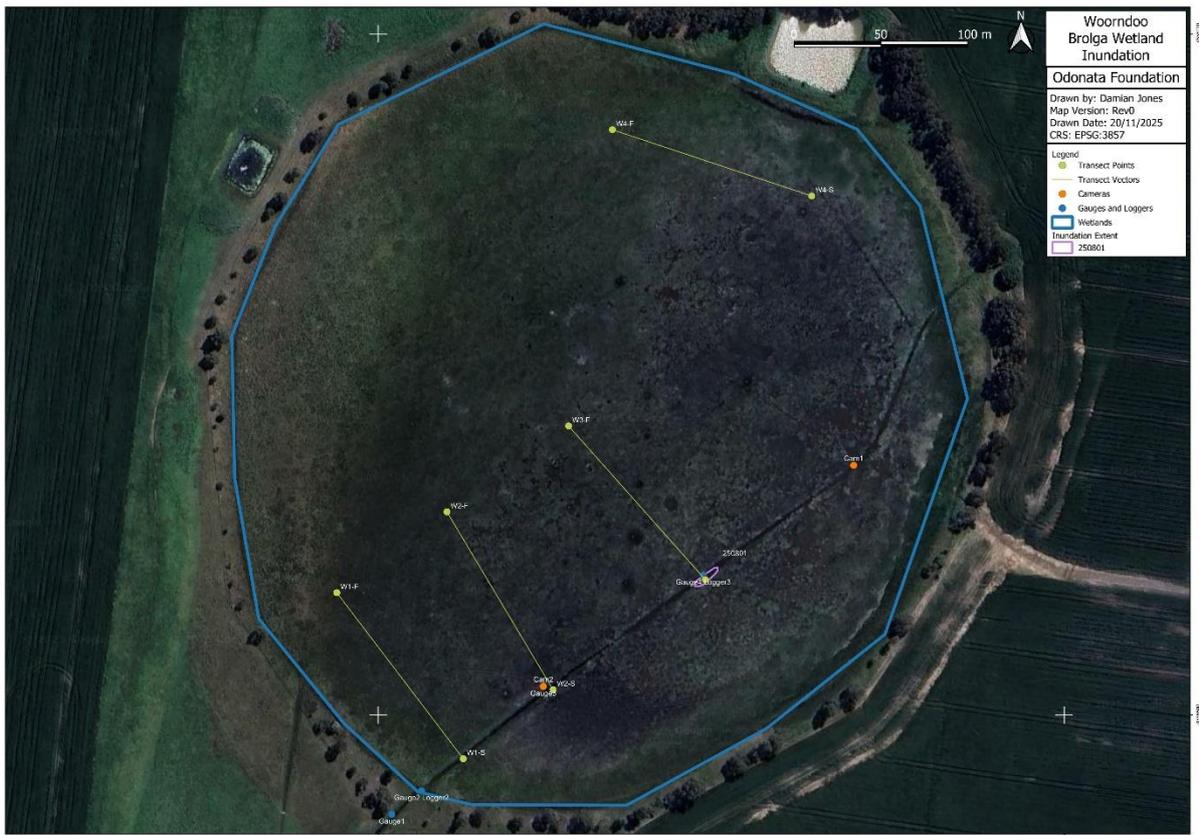
Figure 18 Woorndoo inundation extent

Table 12 summarises inundation conditions for the wetland since the BCP started. Average annual rainfall is 563mm at BoM station 089016 Lake Bolac 14km<sup>6</sup>. Figure 18 shows inundation extent conditions for 2025. The wetland only filled within the drainage channel covering an area of about 50m<sup>2</sup> or <0.1% of the wetland to a maximum depth of <10cm.

Lower than average rainfall made 2025 the third consecutive year where the wetland did not meet the wetland performance target of 30cm inundation over 75% of the wetland basin. This has begun to impact the composition of vegetation observed at the site, the DST outcome, and likelihood of Broilgas visiting the site. See the sections below.

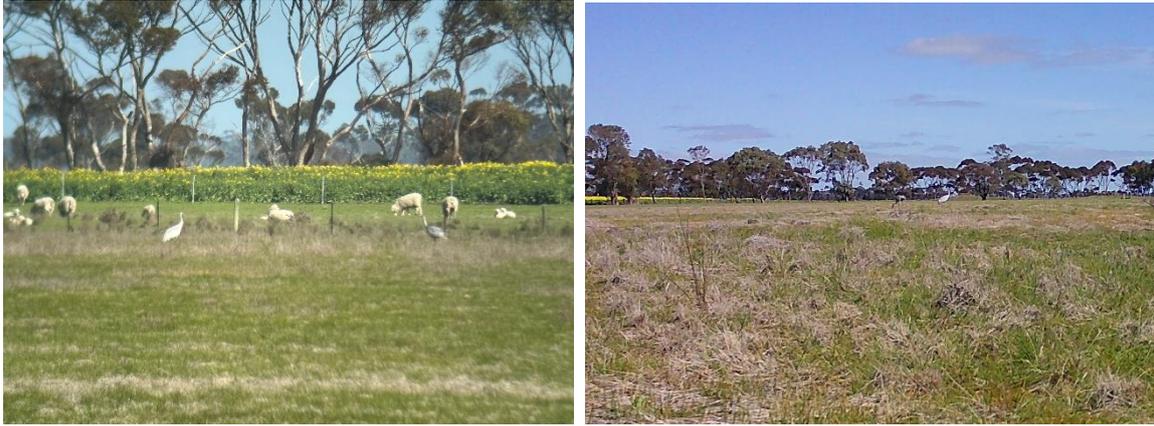
Figure 19 Woorndoo Brolga sightings. (L-R) 30/8/25 through binoculars, 5/9/25 by wildlife camera.

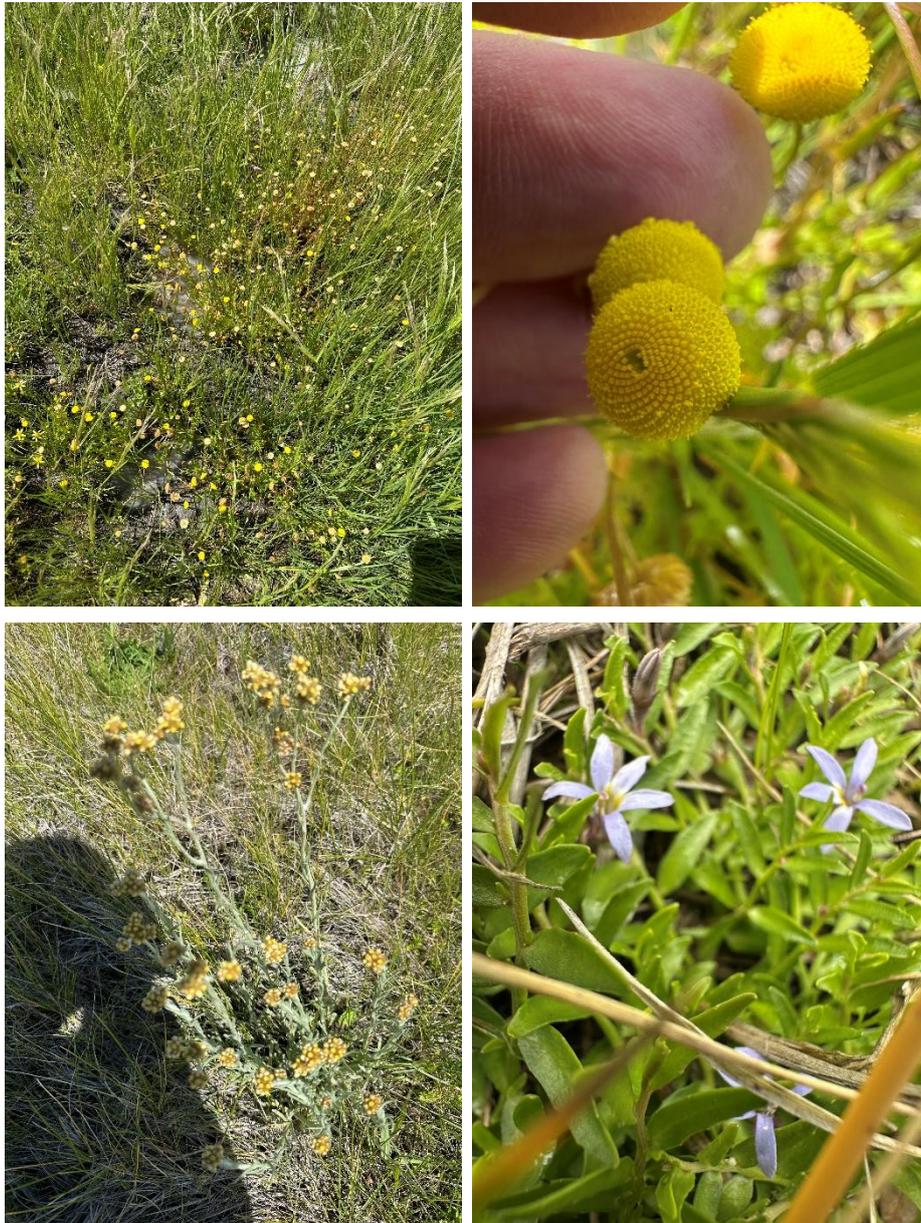
Figure 20 Woorndoo native herbs (L-R T-B) Wiry Buttons, Water Buttons, Jersey Cudweed, Poison Lobelia.

However, it was still encouraging to see good quantities of native herb species, typically in previously inundated areas and often NOT on the survey transects. In particular (also see Figure 20):

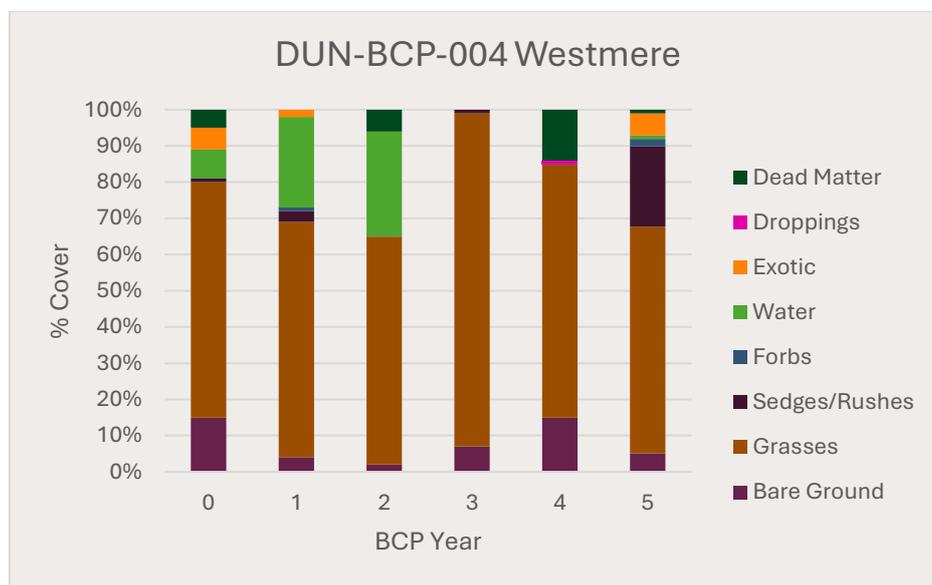
Figure 21 Westmere coverage % by type.

Plan Year	Date	Coverage Type (%)							
		Bare Ground	Grasses	Sedges/Rushes	Forbs	Water	Exotic	Droppings	Dead Matter
0	8/12/2020	15	65	1	0	8	6	0	5
1	14/01/2022	4	65	3	1	25	2	0	0
2	7/03/2023	2	63	0	0	29	0	0	6
3	6/12/2023	7	92	1	0	0	0	0	0
4	28/11/2024	15	70	0	0	0	0	1	14
5	12/11/2025	5	62	22	2	1	6	0	1

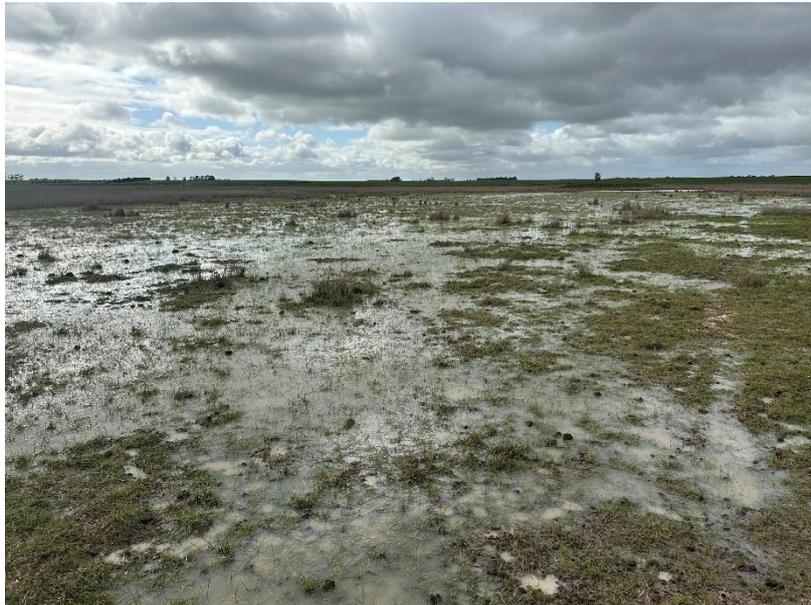
Table 16 summarises inundation conditions for the wetland since the BCP started. Average annual rainfall is 513mm at BoM station 089112 Westmere 4km distant<sup>7</sup>. Figure 23 and Figure 24 show inundation extent conditions for 2025. The wetland filled to an area of about 4ha or 14% of the wetland to a maximum depth of <10cm.

Figure 23 Westmere at maximum inundation, depth <10cm.

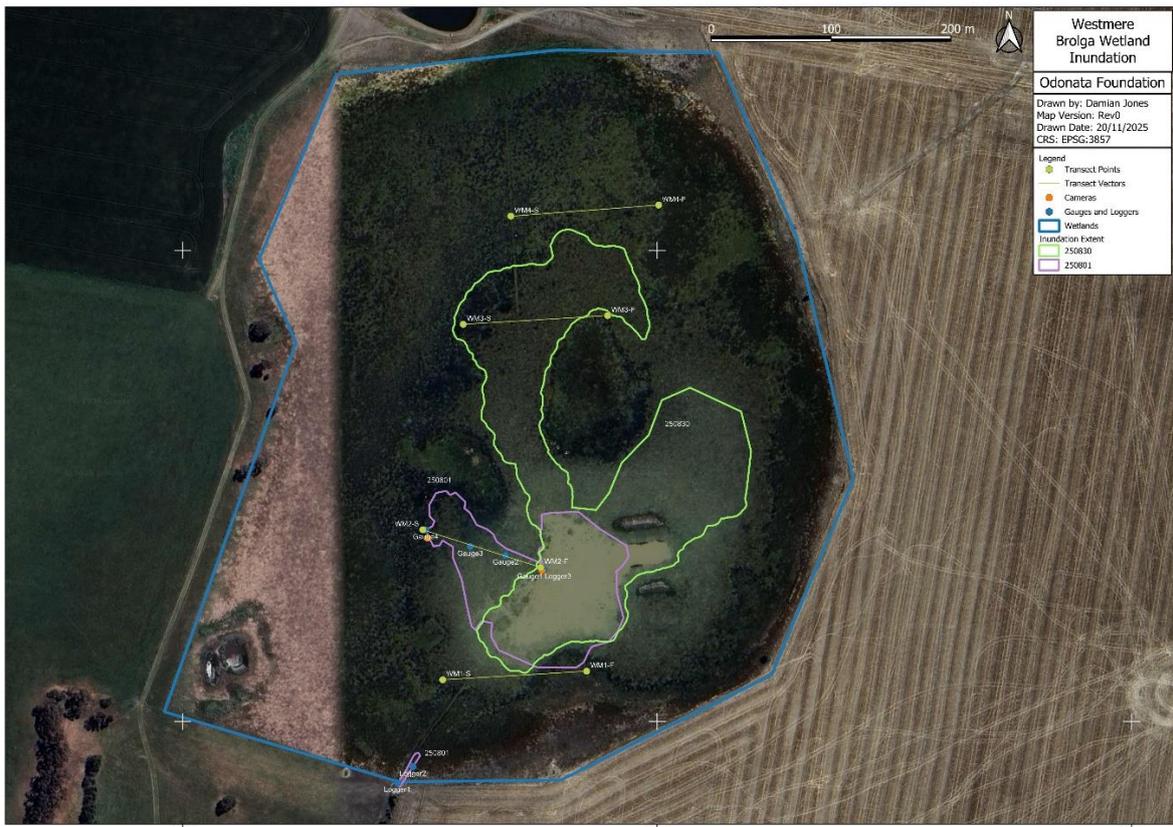
Figure 24 Westmere inundation extent

Lower than average rainfall made 2025 the third consecutive year where the Caramut wetland did not meet the wetland performance target of 30cm inundation over 75% of the wetland basin. This begun to have an impact on the composition of vegetation observed at the site, the DST outcome, and likelihood of Brolgas visiting the site. See the sections below.

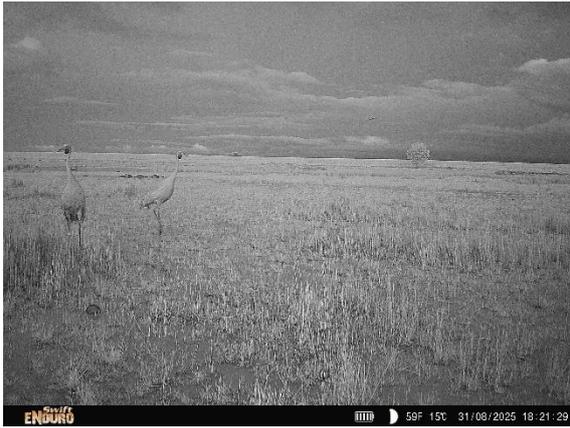
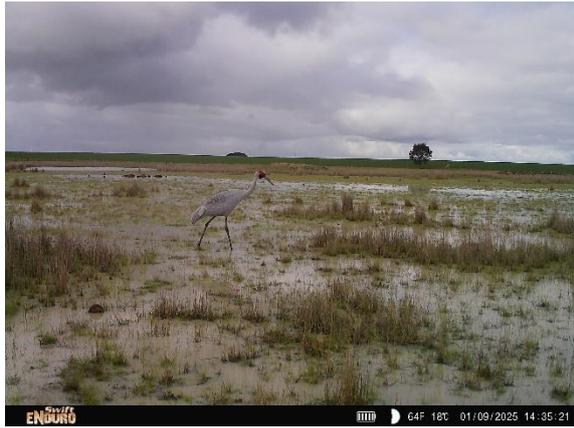
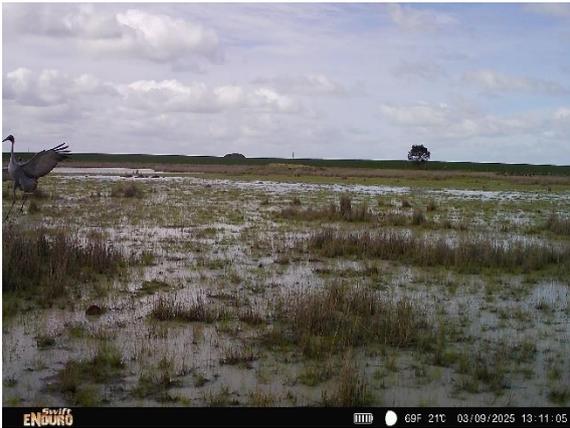
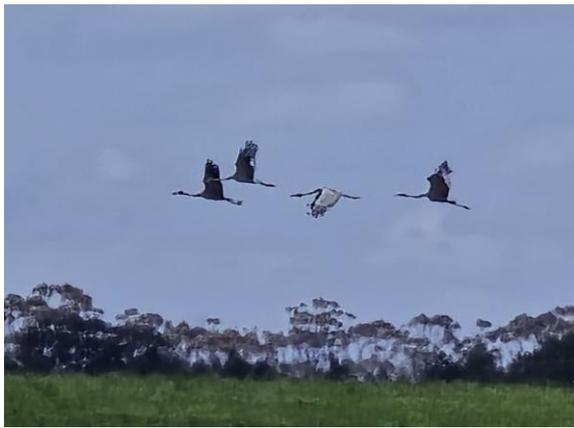
Figure 25 Westmere Brolga sighting examples. (L-R T-B) 31/8/25, 1/9/25, 3/9/25 (courting), 12/11/25 (overhead during veg survey).

Table 19 shows all brolgas sightings from the reporting period. See Figure 25.

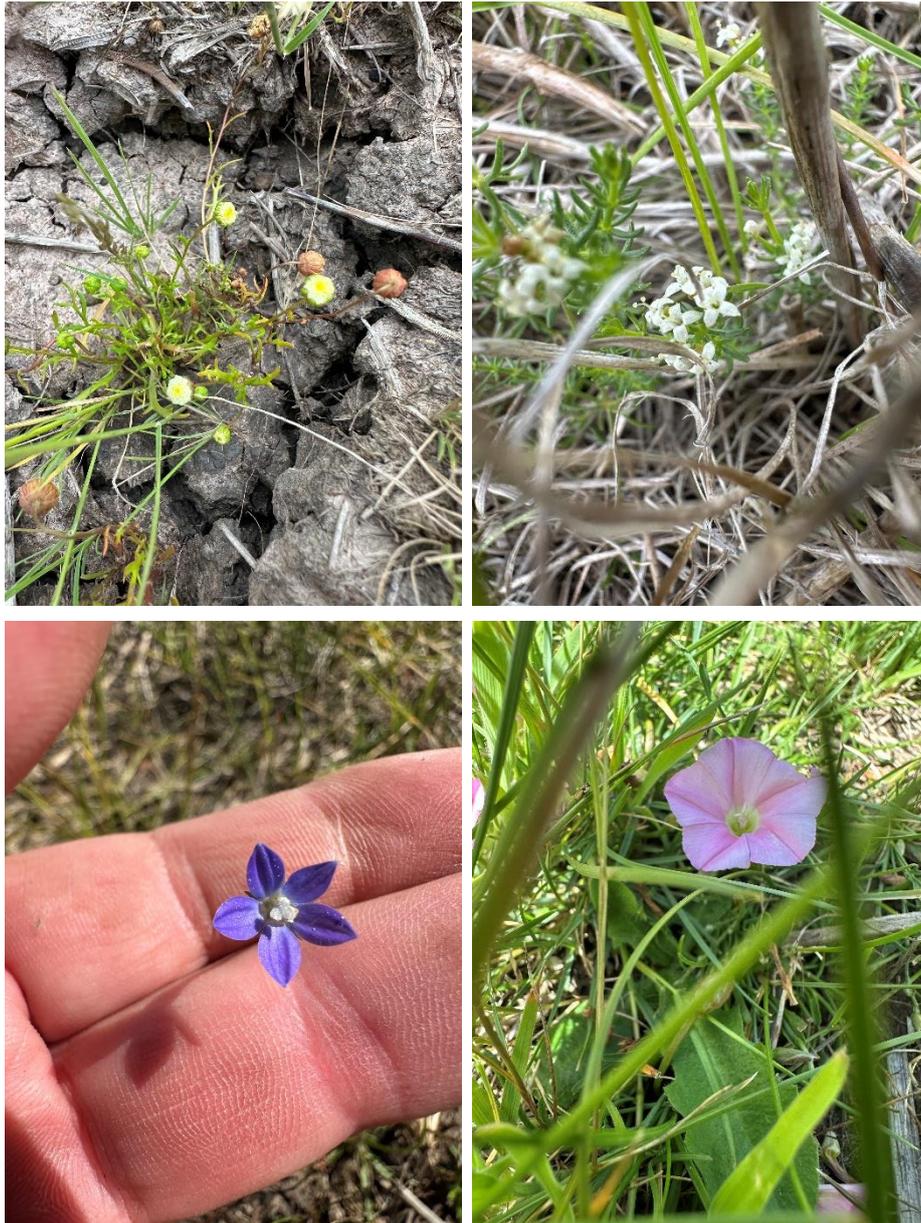
Figure 26 Westmere native herbs (L-R T-B) Ferny Buttons, Common Woodruff, Australian Bluebell, Australian Bindweed.

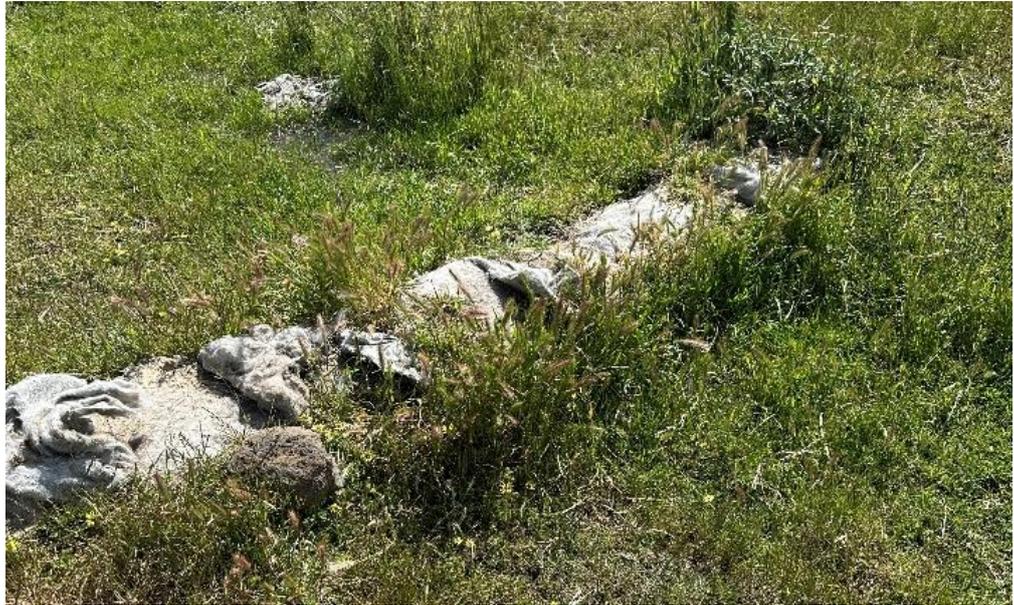
*Figure 30 Westmere drain-block sandbags.*

The exception is at DUN-BCP-004 Westmere, see Figure 30. Here the sandbags are exposed and have degraded. At least two sandbags have been displaced from the drain-block. This drain-block requires repair/rebuilding.

- DUN-BCP-004 Westmere repair or replace the degraded drain-block.
- DUN-BCP-001 Caramut control Phalaris. The landowner plans to crash graze at the end of breeding season and spray in autumn.
